Cold Bonding with Belzona at Two Major Tank Farms

Industry: Chemical & Petrochemical
Application: TCC-Tanks and Chemical Containment Areas
Substrate: Carbon steel
Products: Belzona 1111 (Super Metal)

Customer Location: Netherlands
Application Date: January 2022

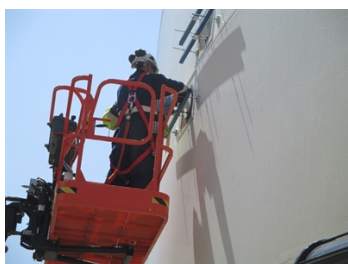
Application in progress

The first customer, a renowned global infrastructure provider, wished to make their operations more sustainable by installing solar panels on the top of their tanks. However, before the panels themselves could be implemented, cable ducts and supports needed to be installed across the entire structure. Such a large number of panels required around 500 brackets be cold bonded on to the live oil tanks, as hot work was out of the question.

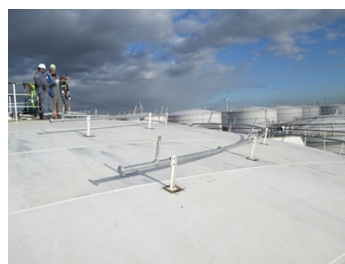
Brackets bonded in place
