Belzona 4311 on Chemical containment Area

ID: 9399

Application: TCC-Tanks and Chemical Containment Areas

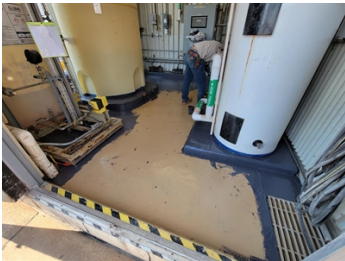
Beginning of the application

The floor was hand propped with angel grinders and diamond tip blades. After that it was cleaned and a first back coat was applied of Belzona 5811. After it was cured a two coat system was applied of Belzona 4311 gray and red.

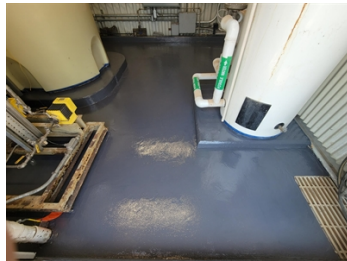
Application of first coat of Belzona 4311 gray

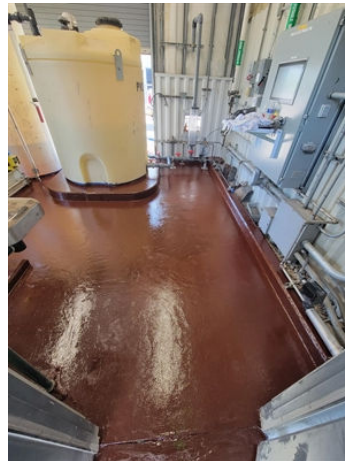
Application of second coat of Belzona 4311 red

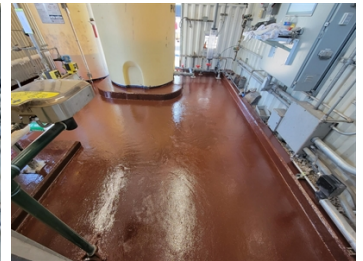
Application complete
