# BELZONA FORMS FLEXIBLE SEAL IN CHEMICAL LOADING AREA

ID: 94

**Industry:** Chemical & Petrochemical  
**Application:** TCC-Tanks and Chemical Containment Areas

**Customer Location:** Petrochemical plant  
**Application Date:** July 1995

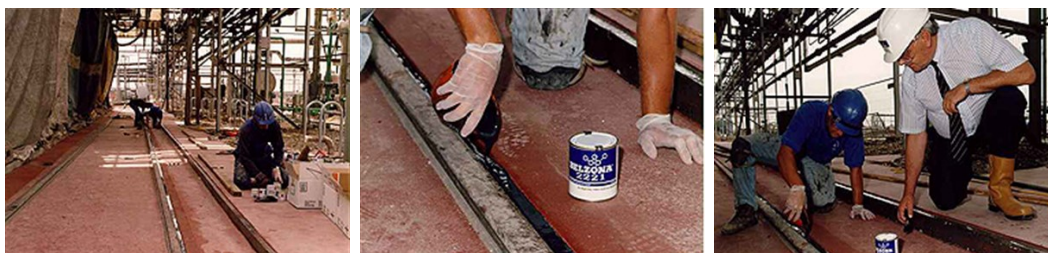
## Photograph Descriptions

Seal required between concrete/epoxy screed and steel rails to prevent ingress of chemicals

- \* General view of the loading area ,
- \* Belzona® 2221 being poured to seal between screed and rail ,
- \* On site supervision provided by the Consultant to ensure specification was closely followed ,

Application was carried out in accordance with Belzona System Leaflet TCC-12
