Belzona protects GRP water tanks

Industry: Local Authorities & Municipalities
Application: TCC-Tanks and Chemical Containment Areas
Substrate: GFRP
Products: Belzona 5811DW (DW Immersion Grade)

Customer Location: Scotland
Application Date: June 2016

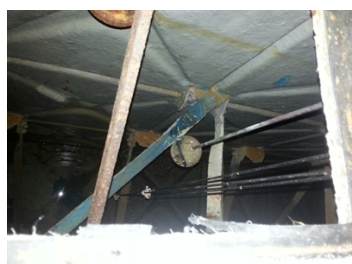
Two GRP cold water storage tanks were in need of relining to protect the substrate & bring up the hygiene standards of the tanks.

Before internal

The tanks were grit blasted to clean & prepare the GRP substrate. Two coats of Belzona 5811 DW2 were then applied.

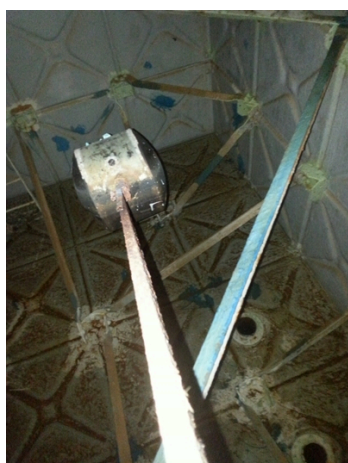
Complex geometry

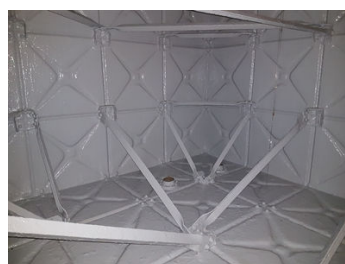
Completed application
