Belzona protects GRP water tanks

Industry: Local Authorities & Municipalities
Application: TCC-Tanks and Chemical Containment Areas
Substrate: GFRP
Products: Belzona 5811DW (DW Immersion Grade)

Customer Location: Scotland
Application Date: June 2016

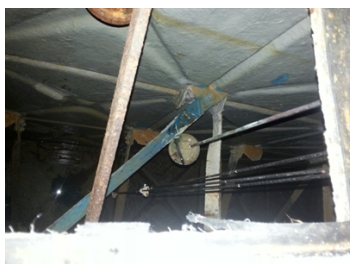
Two GRP cold water storage tanks were in need of relining to protect the substrate & bring up the hygiene standards of the tanks.

Before internal

The tanks were grit blasted to clean & prepare the GRP substrate. Two coats of Belzona 5811 DW2 were then applied.

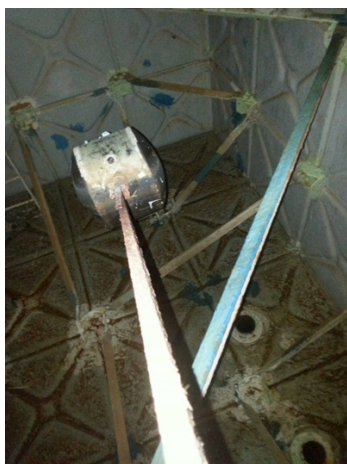
Complex geometry

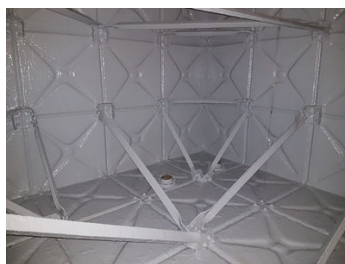
During inspection
