# BELZONA 3412 FLANGE PROTECTION SYSTEM

ID: 9431

Customer Location: EDF ENERGY HEYSHAM LANCASHIRE  
Application Date: June 2024

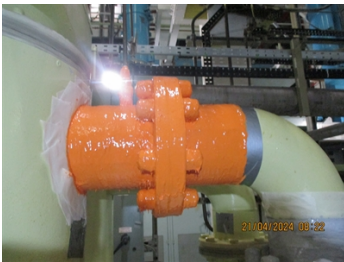
FLANGE & FASTENINGS PROTECTION

Altrad services coating department were recently approached by EDF Energy to assist with encapsulating approximately 140 flanges to the turbine stator water system. The flanges were being encapsulated due to air being drawn into the system, from the vacuum side of the stator water. These levels were higher than normal, so rather than taking the full system or unit out of service, Belzona 3412 would be used for the task, until the system could be brought out of service for maintenance.

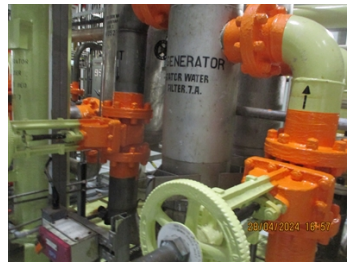
2 X COAT SYSTEM OF BELZONA 3412 PROTECTING FLANGE GASKET AREAS AND FASTENINGS.

Application surface prep, done with emery cloth making sure all surface were clean and any debris removed, the application as per the IFU was carried out without any problems.

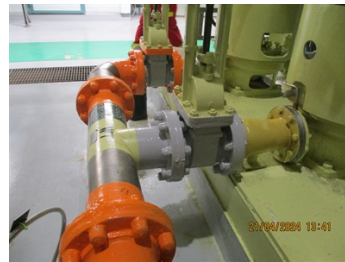
MULTIPLE FLANGES SHOWING FIRST & FINAL COAT APPLICATIONS.

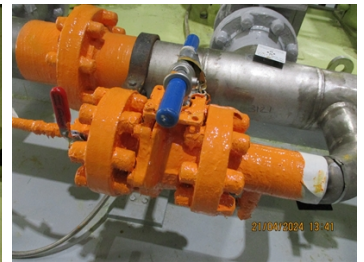
BELZONA 3412 CAN BE APPLIED TO ALL GEOMETRIES AND SEAL THE FLANGE AND FASTENINGS, EASY INSPECTION AND RESEAL.

The cost of Belzona 3412 system is not prohibitive as in this case we have sealed the leaks and added protection to the substrate, inspection is easily done by peeling back the Belzona 3412 and resealing after maintenance.
