BELZONA WEATHERPOOFS POROUS STONework

Industry: Buildings & Structures
Application: WPA-Wall Problem Areas
Substrate: Sandstone
Products: * Belzona® 5122 (Clear Cladding Concentrate) ,

Customer Location: Private House, Manchester, England
Application Date: August 2007

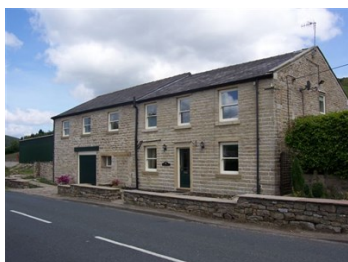
House had been recently renovated and sand blasted externally. This process removed the wetherproofing properties of the stonework and as a result moisture was penetrating into the house.

- * View of property ,
- * Windows masked up and ready to go ,
- * Applying Belzona® 5122 with spray unit ,
- * Application close up ,
