# BELZONA PROVIDES LONG TERM PROTECTION AGAINST UNDER FLOOR CORROSION

ID: 945

Customer Location: Petrochemical Plant - UK  
 Application Date: May 2005

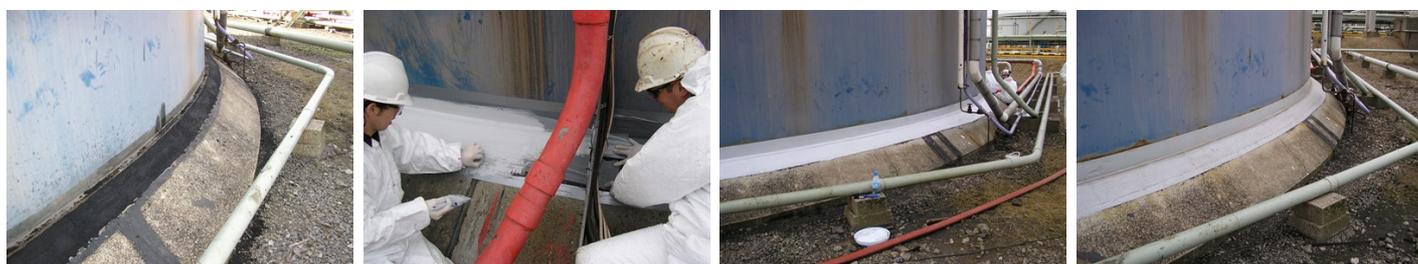
## Photograph Descriptions

As a result of water ingress through the mastic type seal, under floor corrosion had occurred to an extent that the floor needed replacing. The customer was looking for a longer lasting, more effective base seal to satisfy government agency requirements.

- \* Before application of the Belzona system after new floor fitted ,
- \* Application in progress ,
- \* Application complete ,
- \* Completed application over 2 years later ,

Carbon steel Paraxylene storage tank.

The application was carried out in accordance with Belzona Know-How System Leaflet GSS-3
