BELZONA BONDS BUSHES INTO TETHER BLOCK

ID: 951

Industry: Oil & Gas
Application: MPT-Mechanical Power Transmission

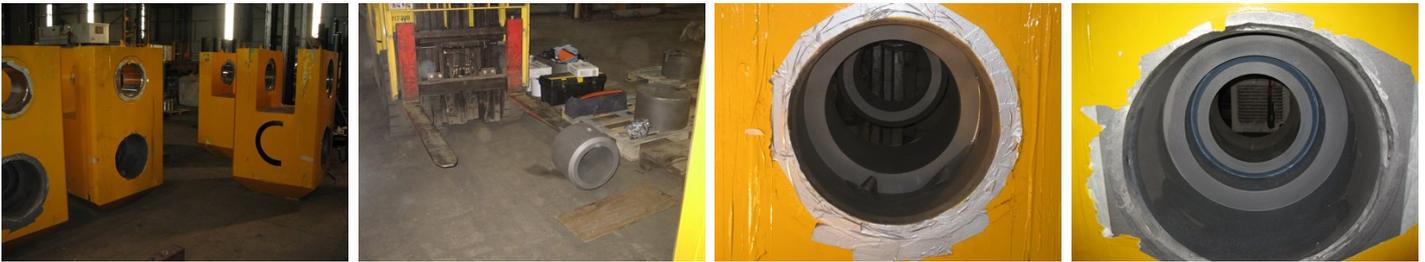
Photograph Descriptions

Welding the bushes had failed and Mechanical means had been ruled out by the client

- * Tether Blocks ,
- * Bush ,
- * Dry fit of Bush ,
- * Completed job ,

Requirement to secure Bushes into the Tether Block for a 5 megawatts power generation buoy to be located in the North Sea

Application was carried out in accordance with a modified Belzona Know-How System Leaflet MPT-8.
