New desalters lining

ID: 9606

Industry: *Chemical & Petrochemical*
Application: *TCC-Tanks and Chemical Containment Areas*
Substrate: *Cast Iron*
Products: *Belzona 1593*

Customer Location: *THESSALONIKI GREECE*
Application Date: *September 2024*

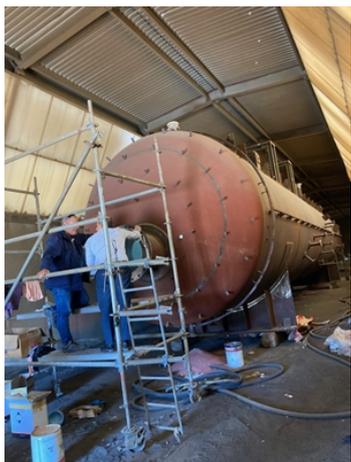
view of vessel

The application was carried out in accordance with Belzona Know-How System Leaflet TCC-5. After grit blasting to SA 2.5 a two-coat system of Belzona 1593 was hand applied to the needed area

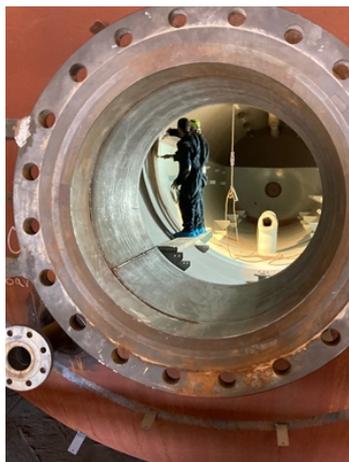
application in progress

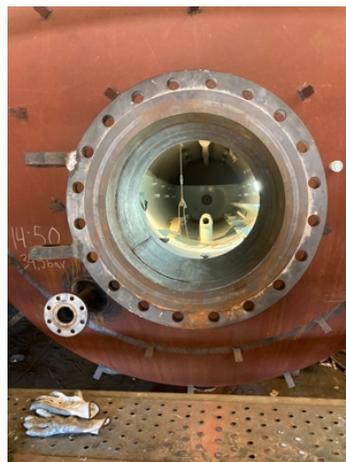
application in progress

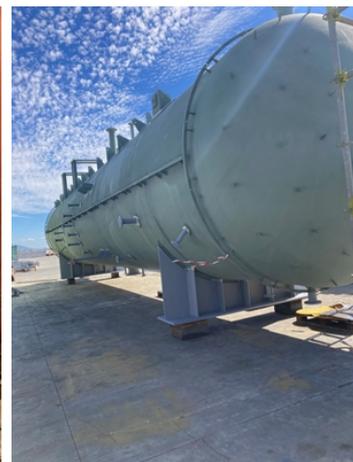
Vessel ready to delivered
