New desalters lining

ID: 9606

Industry: Chemical & Petrochemical
Application: TCC-Tanks and Chemical Containment Areas
Substrate: Cast Iron
Products: Belzona 1593

Customer Location: THESSALONIKI GREECE
Application Date: September 2024

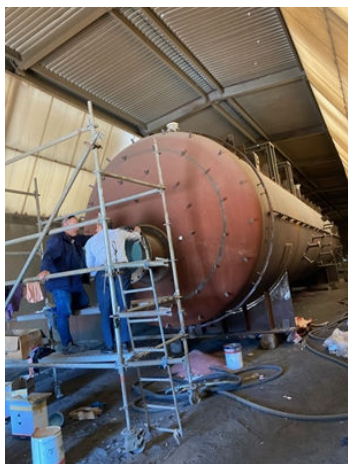
view of vessel

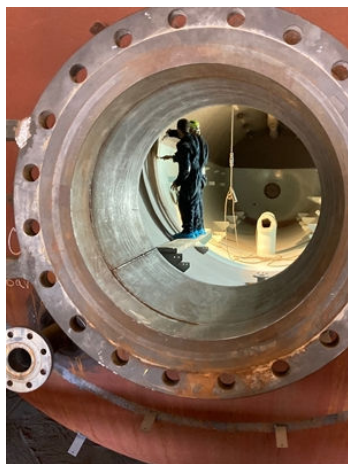
application in progress

The application was carried out in accordance with Belzona Know-How System Leaflet TCC-5. After grit blasting to SA 2.5 a two-coat system of Belzona 1593 was hand applied to the needed area

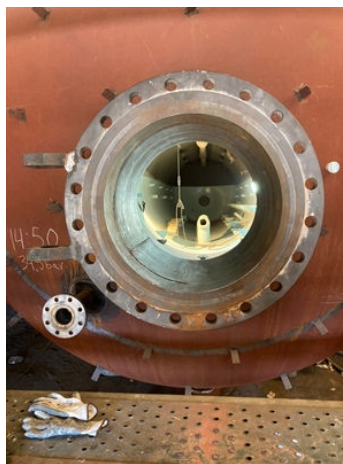
application in progress

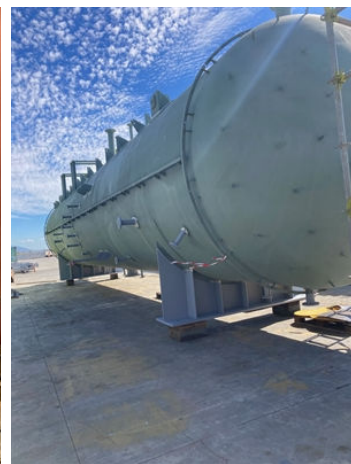
Vessel ready to delivered
