# Drive roller for a conveyor belt

ID: 9624

Application: *ENC-Engines and Casings*

Products: *Belzona 2211 (MP Hi-Build Elastomer), Belzona 5811 (Immersion Grade)*

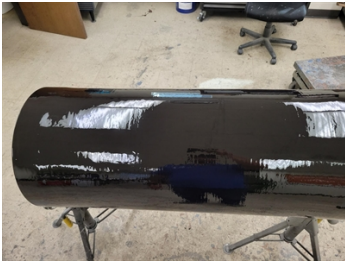
Belzona first coat on pully

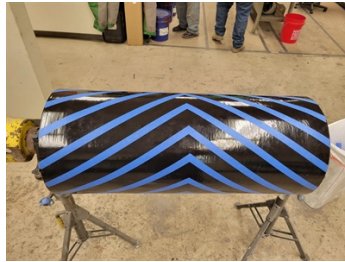
Demarcation on pully for Belzona application

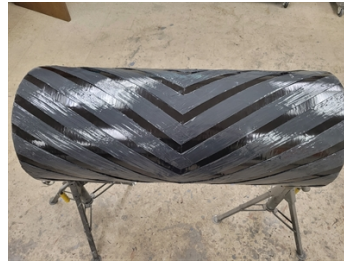
Belzona 2211 first coat

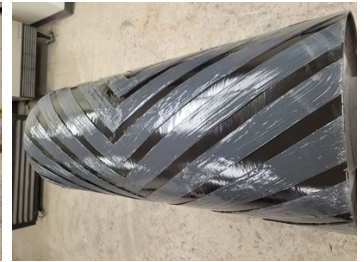
Belzona 2211 second coat
