Lining of a yacht's diesel tanks

ID: 9645

Customer Location: Spanopoulos Shipyard (Salamina)

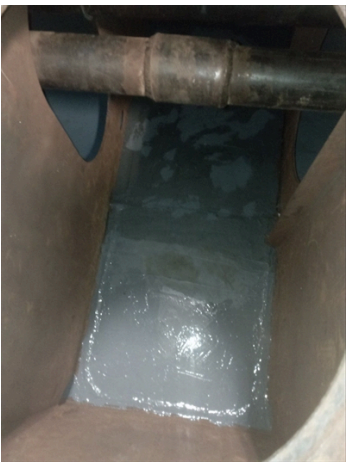
Application of Belzona 1311 to rebuild pitted areas

Before 1311 was applied to the substrate after it was grit blasted. The lining material was Belzona 1321.

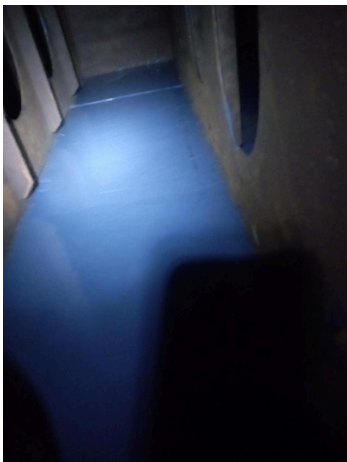
Application of Belzona 1321 on top of Belzona 1311
