Protecting a new tank lining in a chemical plant from Phosphoric acid attack

Industry: *Chemical & Petrochemical*
 Application: *TCC-Tanks and Chemical Containment Areas*
 Substrate: *Carbon steel*
 Products: *Belzona 4341 (Magma CR4)*

Customer Location: *Ontario*
 Application Date: *May 2015*

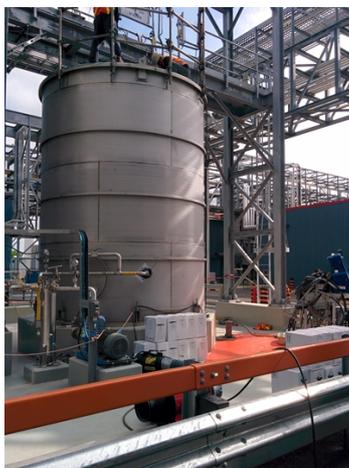
Tank after sand blasting.

The tank and nozzles were blasted to achieve a near white metal finish with a good profile. After the required QA/QC checks, Belzona 4341 was applied to protect the tank and other components from corrosion and offer concentrated chemical resistance.

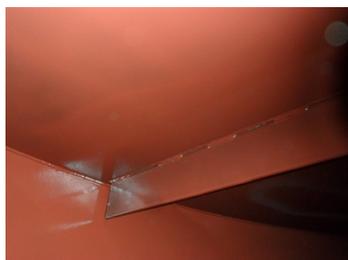
Tank during holiday testing.
