Belzona protects storage vessel from chemical attack.

ID: 9705

Industry: *Chemical & Petrochemical*
Application: *TCC-Tanks and Chemical Containment Areas*
Substrate: *Other*
Products: *Belzona 4311 (Magma CR1)*

Customer Location: *Ontario*
Application Date: *May 2013*

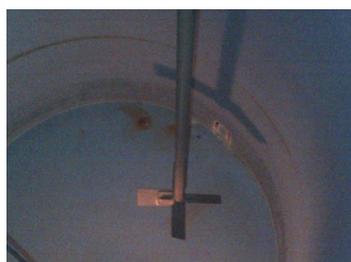
Customer had a storage tank that requires to be protected with a lining that would resist chemical attack, thereby extending its service life.

Tank before abrasive blasting.

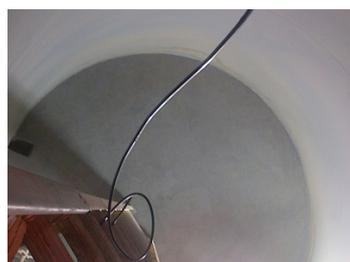
After abrasive blasting surface preparation

The tank and drain areas were blasted to achieve a near white metal finish with a good profile. After the required QA/QC checks, Belzona 4311 was applied to protect the tank and other components from corrosion and offer concentrated chemical resistance.

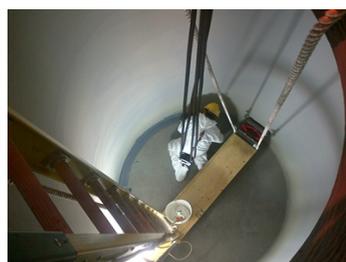
During stripe coating of Belzona 4311

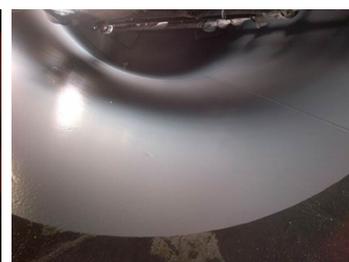
Lining application completed with Belzona 4311.
