Energy Efficiency and Corrosion Resistance Boosted in New Pump with Belzona 1341

Application: CEP-Centrifugal Pumps

Application Date: February 2025

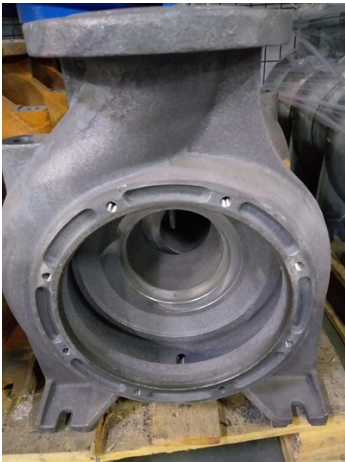
After grit blasting

Application was carried out in accordance to the Belzona Know-How System Leaflet CEP-10 . The surface of the new pump was prepared to SA 2 ½ with a minimal profile of 75 microns, and then coated with Belzona 1341 using a roller and brush.

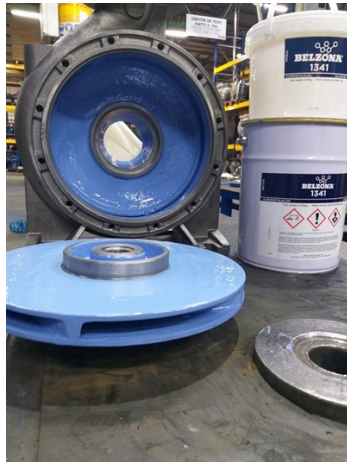
The pump after application

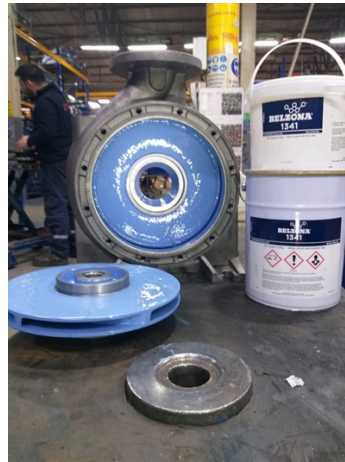
The pump after application
