Drinking water split casing pump coating

ID: 9749

Application: CEP-Centrifugal Pumps

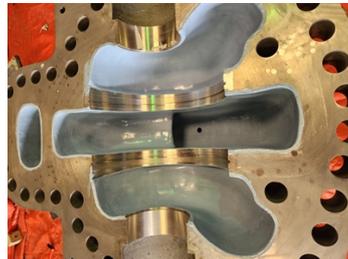
Pump after blasting, surface pitting is visible

We Grit blasted the surface to reach near white metal and 75 um microns as recommended by Belzona IFU. We made sure the salt level over the surface was very minimal, and we rebuilt the pitting with Belzona 1111, sweep blast, then 2 coat systems of 1341 at 250 um each to reach a total of 500 um average.

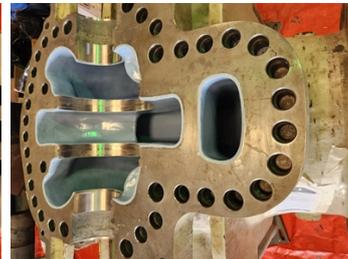
Pump coating with Belzona 1341
