BELZONA SOLUTIONS FOR INTERNAL COATING OF VESSEL

ID: 9754

Industry: Oil & Gas
Application: TCC-Tanks and Chemical Containment Areas
Substrate: Carbon steel
Products: Belzona 1391T

Customer Location: DUBAI, UNITED ARAB EMIRATES
Application Date: December 2024

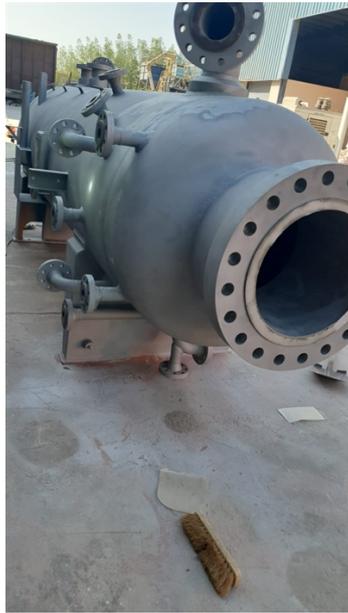
Work in progress for the full vessel.

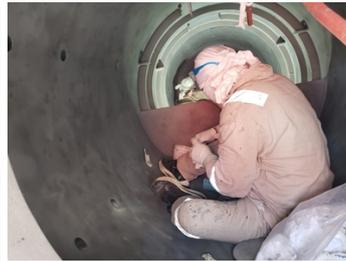
During the application of Belzona 1391T in the vessel, the applicator followed Belzona Know-How System Leaflets TCC-5, TCC-16a, and TCC-16b.

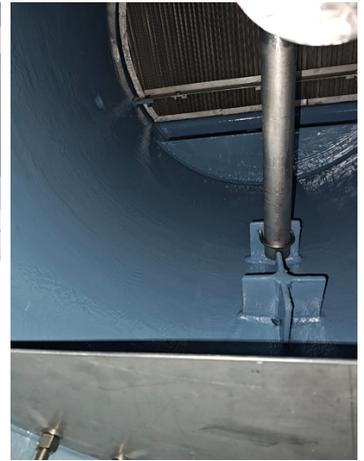
A two-coat system of Belzona 1391T was achieved for the vessel's internal lining.
