# Belzona Provided a Better Grip on a Caisson Clamp Pipeline support

ID: 9777

Customer Location: AL Shaheen Field Offshore Qatar

Application Date: January 2023

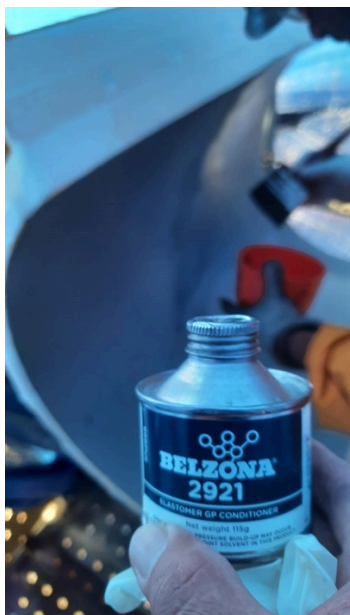
Belzona 2921 Surface Conditioner Application

The application was done using a stiff bristled brush in accordance with Belzona System Leaflet SHM-12.

Belzona 2921 (Elastomer GP Conditioner) is a surface conditioner which is the elastomeric primer required for better adhesion of Belzona elastomers onto any rigid and flexible substrates.

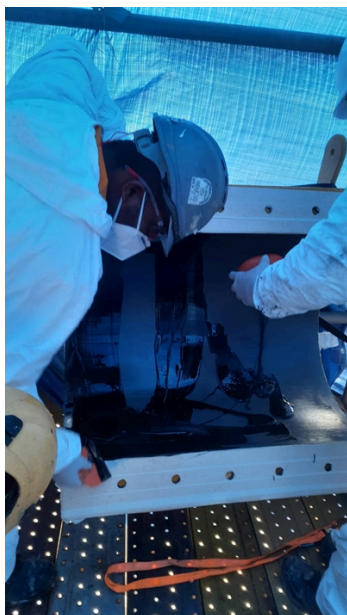
Belzona 2111 (D & A Hi-Build Elastomer) Bonding material application

The newly fabricated caisson clamp needs to be sheathed with a corrugated neoprene rubber, and it must be bonded to the clamp using a tougher bonding material with a required 1.5 mm thick bonding line.

Belzona 2111 (D & A Hi-Build Elastomer) can be used as rebuilding and adhesive for elastomeric and non elastomeric substrates. Easy to apply without any hot work for bonding.

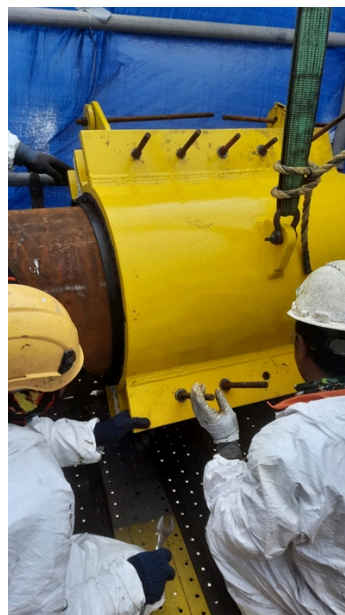
Clamping using a dummy pipe to compress the Neoprene Rubber sheet

Using a dummy pipe with the same diameter as the actual pipe, the corrugated neoprene rubber sheet was bonded in a sandwich between the clamp and the dummy pipe by tightening the bolts.

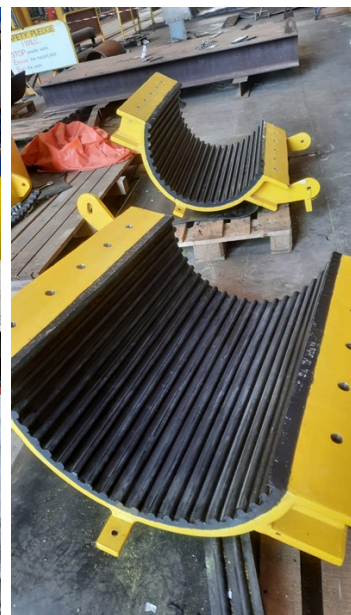
Completed Bonding Application
