# BELZONA SOLUTION FOR TANK BASE SEALING - 38.5M DIAMETER

ID: 9809

Industry:	Power	Customer Location:	Dubai, United Arab Emirates
Application:	GSS-Gaskets, Seals and Shims	Application Date:	February 2025
Substrate:	Carbon steel		
Products:	Belzona 3111 (Flexible Membrane), Belzona 3911 (PSC Surface Conditioner), Belzona 3921 (GSC Surface Conditioner), Accessories

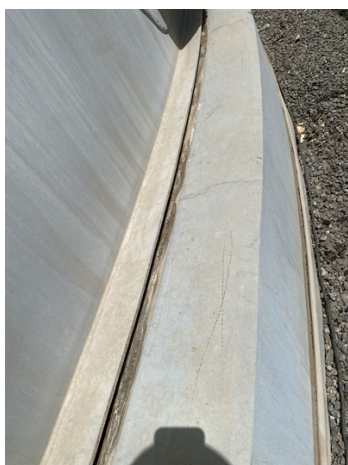
Exposure to harsh environmental conditions can compromise the seal around the annular plate, allowing moisture and air to infiltrate the area.

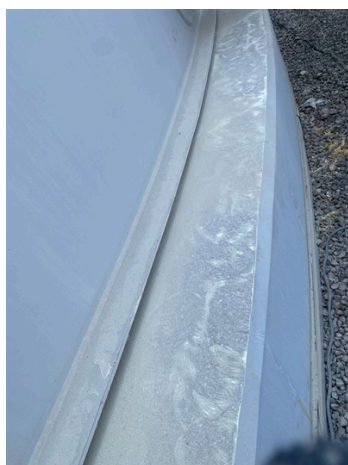
The annular tank base was meticulously prepared, followed by the application of Belzona 3921 and Belzona 3911 primers to the steel and concrete surfaces, respectively.

The application was carried out in line with Belzona Know-How System Leaflet GSS-03. The annular tank base underwent thorough surface preparation, after which Belzona 3921 and 3911 primers were applied to the steel and concrete substrates. Bridging tape and Belzona 9321 reinforcement sheet were then installed to promote optimal adhesion of the top layer. To complete the system, Belzona 3111 was applied in two coats, delivering long-term sealing and weatherproof protection.

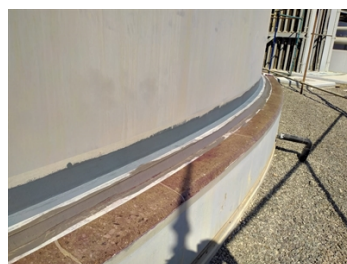
Bridging tape and the Belzona 9321 reinforcement sheet were subsequently applied to ensure strong adhesion of the topcoat.

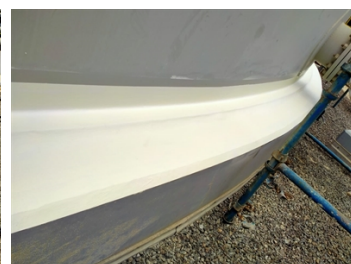
Belzona 3111 was applied in a two-coat system, providing durable sealing and long-lasting weatherproof protection.

A Belzona flexible membrane system, reinforced with a specialist sheet, encapsulates the tank base perimeter while its microporous structure allows trapped moisture to escape, preventing corrosion beneath the seal.
