Cold Bonding Using Belzona 7311 on a Yacht Hull

ID: 9834

Industry: Marine
Application: VPF-Valves, Pipes and Fittings
Substrate: Stainless-steel
Products: Belzona 7311

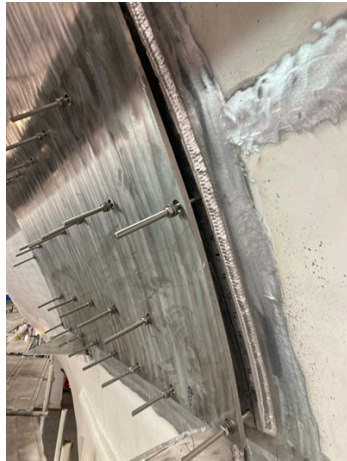
Structure that required the bonding solution.

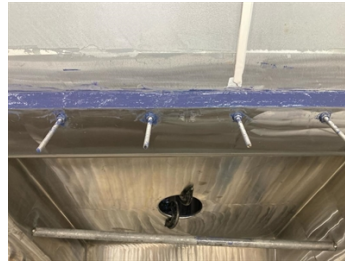
Surface preparation complete.

The hull and the plates were first mechanically prepared according to SSPC-SP11 standards. Belzona 7311 was the chosen solution and was used in conjunction with a threaded mechanical anchoring system. The two components were positioned and aligned using hoists, hydraulic jacks, and threaded rods acting as guides.

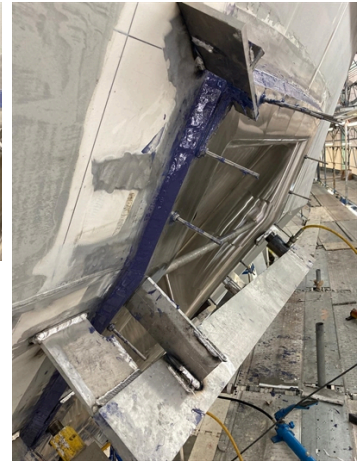
Belzona 7311 applied.
