Belzona 1984 on Sweating Nozzle

ID: 9843

Industry: Oil & Gas
Application: VPF-Valves, Pipes and Fittings
Substrate: Carbon steel
Products: Belzona 1161 (Super UW-Metal), Belzona 1984, Belzona SuperWrap II, Belzona 5831 (ST-Barrier)

Customer Location: Orange Texas
Application Date: June 2025

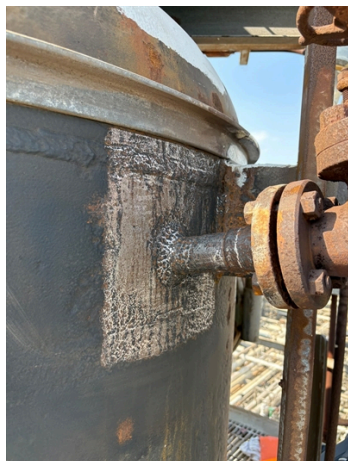
CUI led to excessive corrosion. The vessel operates at sub ambient temperatures which leads to sweating substrate.

Picture of defective area.

Power tool prep to SSPC-SP 11 using sparkless grinders.

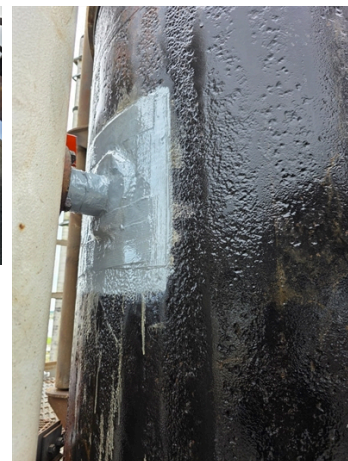
SuperWrap II using 1984 installed onto nozzle. Belzona 1161 was used as the rebuild underneath.

Belzona 5831 used to topcoat system.

This application could not involve any hot work, so sparkless grinders were used to prepare the substrate to SP 11 surface cleanliness levels. Belzona 1161 was used to rebuild the pitting and create a chamfered transition at the nozzle/vessel interface. Belzona SuperWrap II was then installed. The repair wrapped the entire nozzle and flared onto the vessel extending 4 inches beyond the pitting in each direction. Belzona 1984 was allowed to cure and then inspected. Once deemed acceptable the repair was abraded and Belzona 5831 was used to topcoat the composite.
