# MAIN COOLING WATER PUMPS PROTECTED WITH BELZONA

ID: 985

Customer Location: Coal fired power station - UK  
Application Date: 2004

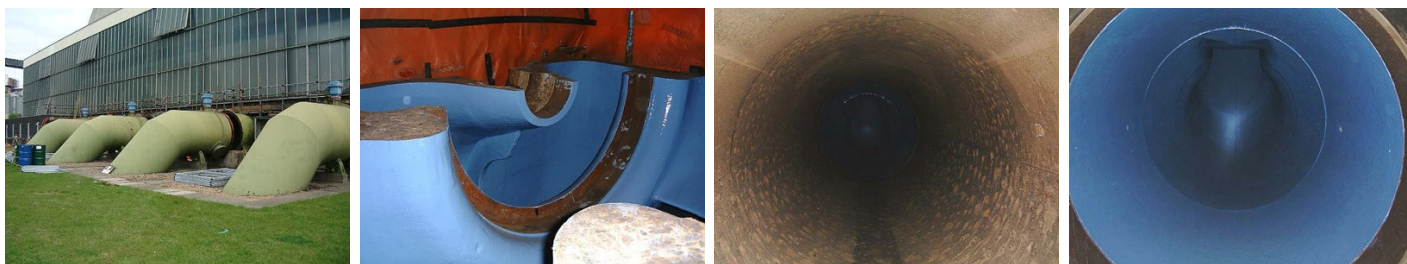
Erosion corrosion particularly on main wearing rings, cut water and delivery tubes.

- \* Scale of pumps can be gauged from the delivery tubes ,
- \* Suction side coated ,
- \* Degree of corrosion evident on the delivery tubes ,
- \* Completed coating ,

Carried out in accordance with Belzona system leaflets CEP-1 and CEP-3. Particular attention was paid to surface preparation with repeated steam cleaning and grit blasting used to remove salt contamination.
