Groundwater leaks into jet fuel pipe repair

ID: 9916

Application: WPA-Wall Problem Areas

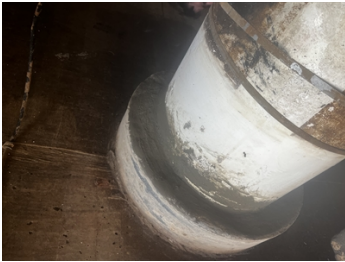
Groundwater was entering around a jet fuel pipe penetration, causing the vault to fill up with water.

Leaking pipe penetration

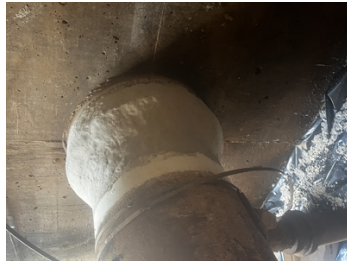
Building up around pipe from concrete with Belzona 4141

Cleaned up area with 5,000 psi pressure washer wiped down with MEK. Applied Belzona 4911 conditioner, applied Belzona 4141 to penetrating areas to build up to a transition. Applied Belzona 5815 with Belzona 9311 reinforcing sheet twice. Went back the next day and no leaks.

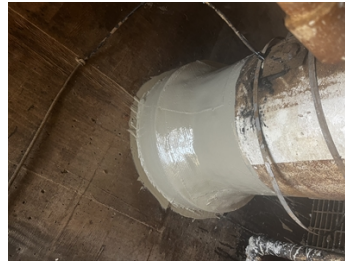
The finished product using Belzona 5815 with 9311 reinforcement
