Cooling tower fan blades repaired and protected

ID: 9922

Application: FBC-Fans, Blowers and Compressors

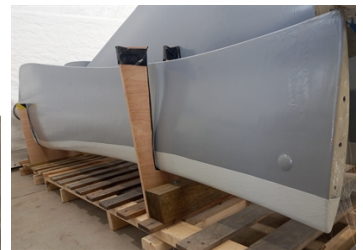
3. Finished blades awaiting dispatch to site

The blades were sanded to provide a key then 2 x coats of 5811 were applied to the total surfaces of the fan blades.

After curing, the 5811 was again abraded along on the leading edge, appx 80mm either side of the blade's leading edge to the length of the blade

2 coats of 5721 was then applied to complete the protective application
