# Tank Repair Composite Wrap

ID: 9925

Products: Belzona 1511 (Super HT-Metal), Belzona 1982 (SuperWrap II), Belzona SuperWrap II, Belzona 5111 (Ceramic Cladding)

Customer Location: Deer Park, TX

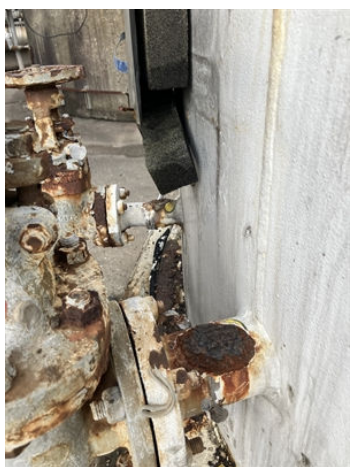
Customer had 4 nozzles coming off a tank that experienced corrosion under insulation. The metal on the nozzles were severely pitted and thin. The nozzles were close to hole through if no action was taken to prevent corrosion. The tank contents are flammable, so hot work would create unwanted downtime.

Insulation removed and can see the pitting / external corrosion on the nozzles

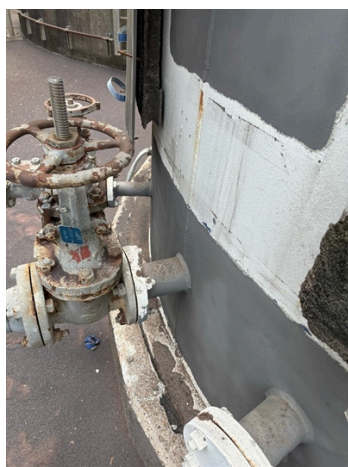
Abrasive blast completed per SSPC-SP10

1. Abrasive blast the application area SSPC-SP10
2. Pit fill and smooth welds with Belzona 1511
3. Composite wrap each nozzle with Belzona 1982/9381 SuperWrap 2 for a 2 wrap/4 layer system. The nozzles were spiral wrapped and composite was flared out onto shell of the tank 10" in all directions.
4. Belzona 5111 was applied as a top coat over the repair

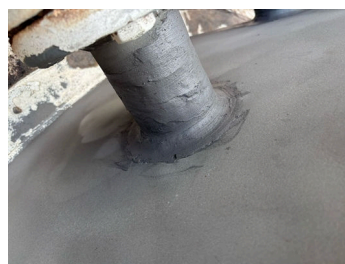
Belzona 1511 was applied to smooth welds, pit fill and rebuild lost metal to help with composite wrap.

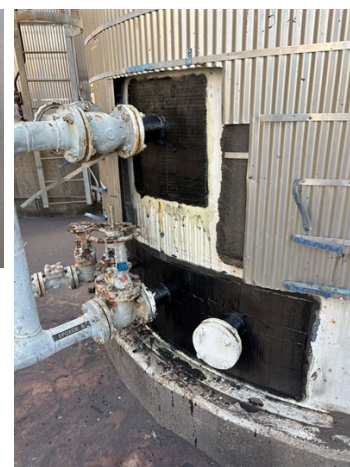
All four nozzles with composite wrap completed.
