Rubber Flange Repair with Belzona 2111

ID: 9976

Industry: Chemical & Petrochemical

Application: VPF-Valves, Pipes and Fittings

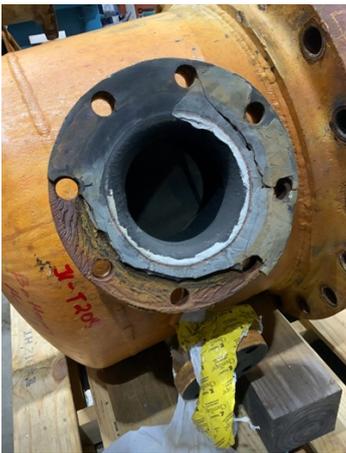
The customer was in outage and discovered the rubber lining of the condenser head was deteriorated and could not go back in to service.

Before Belzona 2111 repair

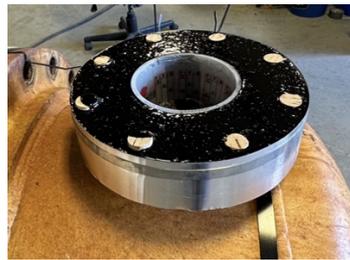
Once we removed the old rubber lining from the flange and prepped the surface we used shim stock to create a mold around the flange. Then we poured Belzona 2111 and let sit overnight.

We removed the current rubber lining of the flange face us in a chisel hammer followed by grit blasting the surface to SSPC-SP 10 specifications.

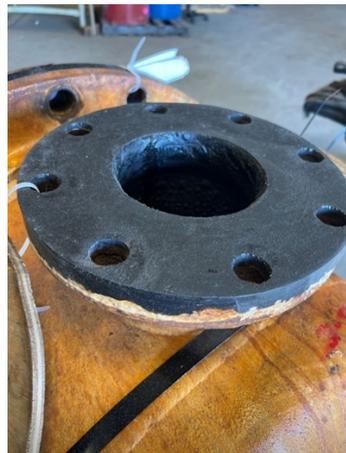
The next day we removed the shim stock to reveal the completion of the Belzona 2111 repair to the flange.
